Manhole Inspection Summary

Manhole # S250__019MH

Insp Date: **4/1/08 12:20 PM**

Location Address: **1352 Sargeant St**

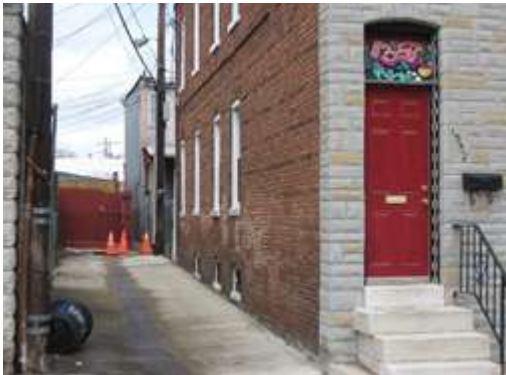
Location View

behind 1352 Sargeant St

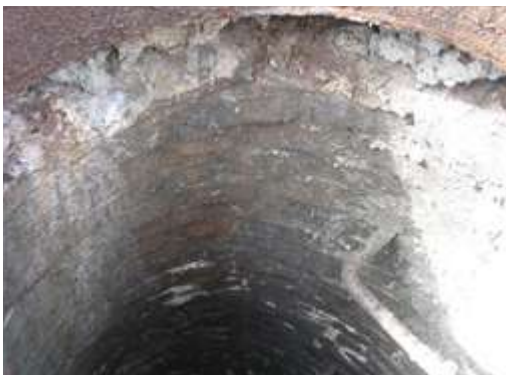
Defect 2

Infiltration from under frame

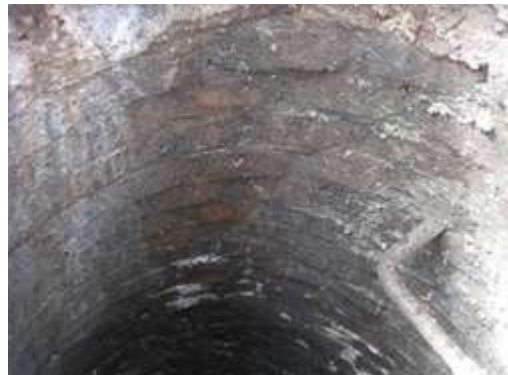
Defect 3

Infiltration: ☐ None ☐ Joint ☐ Cracks ☐ Mortar ☐ Roots ☒ **Wall**

INFILTRATION AT CHIMNEY AND CORBEL

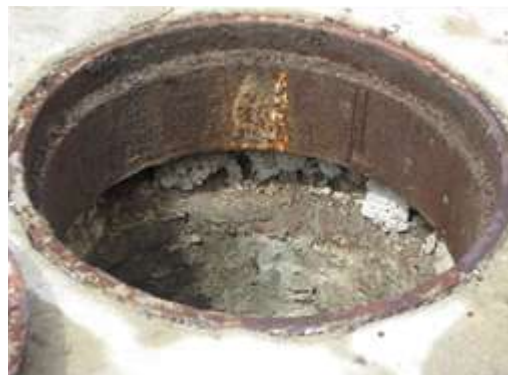
Defect 1

Condition: ☐ Sound ☒ **Cracked** ☐ Root Intrusion ☒ **Loose Brick** ☒ **Deteriorated**

Missing bricks and mortar under chimney, chimney cracked, loose bricks and deteriorating.

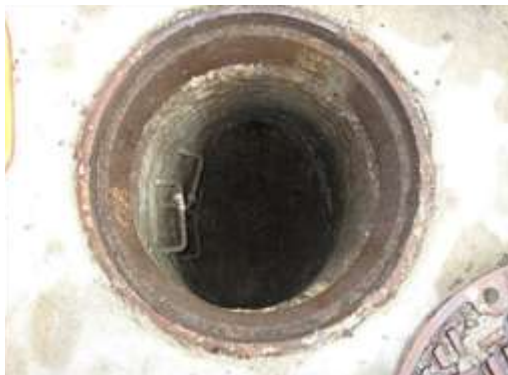
Defect 4

Frame Offset: **1** (in.) Condition: ☒ Sound ☐ Cracked ☐ Leaks

Condition: ☐ Sound ☐ Cracked ☐ Root Intrusion ☐ Deteriorated ☐ Leaks ☒ **Debris**

1" Frame Offset and Channel Debris

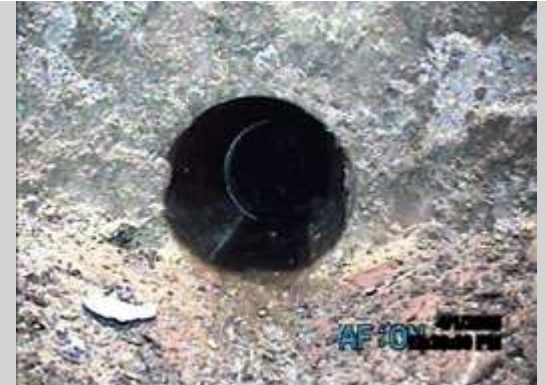
12 O'Clock Outflow

8 in. Circular Gravity Sewer
Pipe Out @ 12 O'Clock

Pipe Height: **8.4** (in.) Rod and Bar (Angled)

Pipe Material: **Clay** ☐ Pipe Lined

Invert Depth: **8.16** (ft.) Flow Characteristics: **None**

Deposits: ☒ None ☐ Mud ☐ Sludge ☐ Debris ☐ Grease

Infiltration: **None**

Pipe Seal Cond: **Sound**
